HAZARDOUS MATERIALS SPECIAL INVESTIGATION REPORT

**COLLISION BETWEEN
A TRACTOR-SEMITRAILER
TRANSPORTING BOMBS AND
AN AUTOMOBILE,
RESULTING IN FIRE AND EXPLOSIONS
CHECOTAH, OKLAHOMA
AUGUST 4, 1985**

NTSB/SIR-87/01

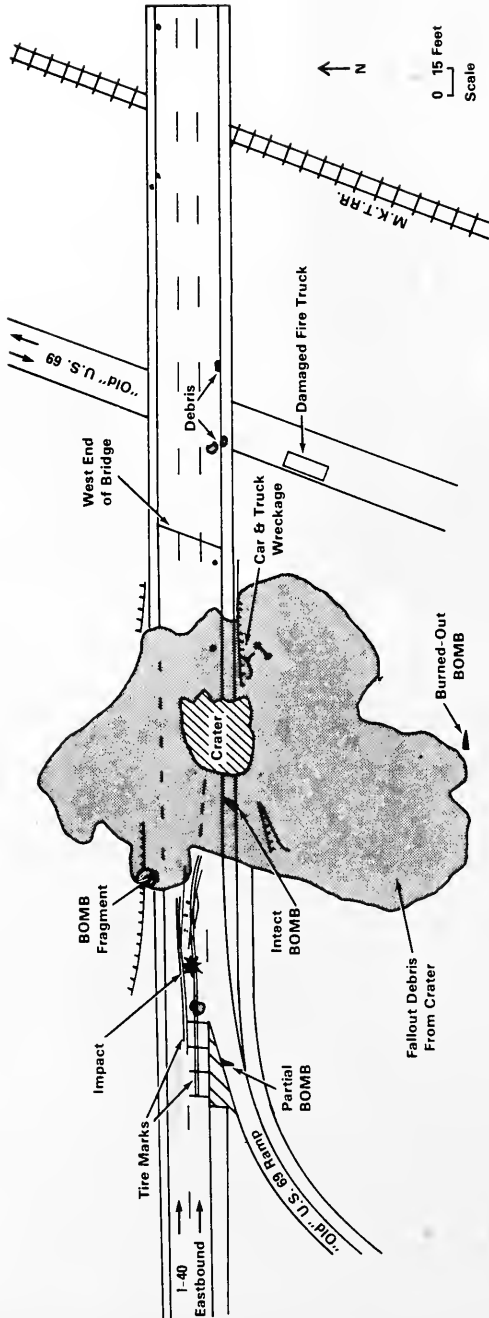
Figure 4.—Diagram of accident site.

The 61st team arrived at the accident site at 8:32 a.m. The 61st commander said that, based on his observation of thin, gray smoke and relatively small fires, he decided little danger of further detonation existed. He requested local emergency response personnel to extinguish grass and brush fires, and he advised local response personnel that evacuation distances could be reduced to a perimeter surrounding the accident site. Personnel from the 61st inspected the area and found one intact, 100 percent filled bomb adjacent to the accident site, one intact 80 to 90 percent burned out bomb about 150 to 175 feet south of the accident site, and one 3 1/2-foot-long rear section of a bomb (filled with explosive filler) approximately 150 to 175 feet southwest of the crater. (See figure 4.)
